# Manhole Inspection Summary

Manhole # S35AA\_003MH

Insp Date: **11/13/07 8:49 AM**

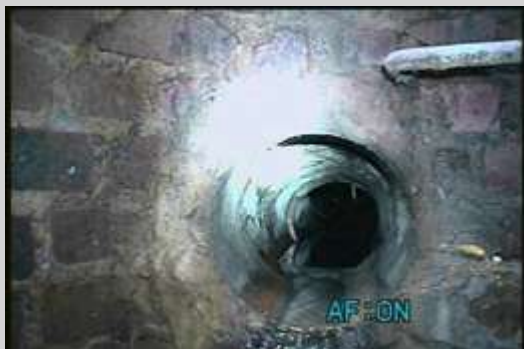
3 O'Clock Inflow

8 in. Circular Gravity Sewer  
Pipe In @ 3 O'Clock

Infiltration: **None** Pipe Seal Cond: **Unknown**
